**Report of Phase I Environmental Site Assessment  
Manget Street Redevelopment Project  
Cobb County, Georgia  
Geo-Hydro Project Number 057929.00**

Manget Street Redevelopment Project  
Cobb County, Georgia  
Geo-Hydro Project Number 057929.00

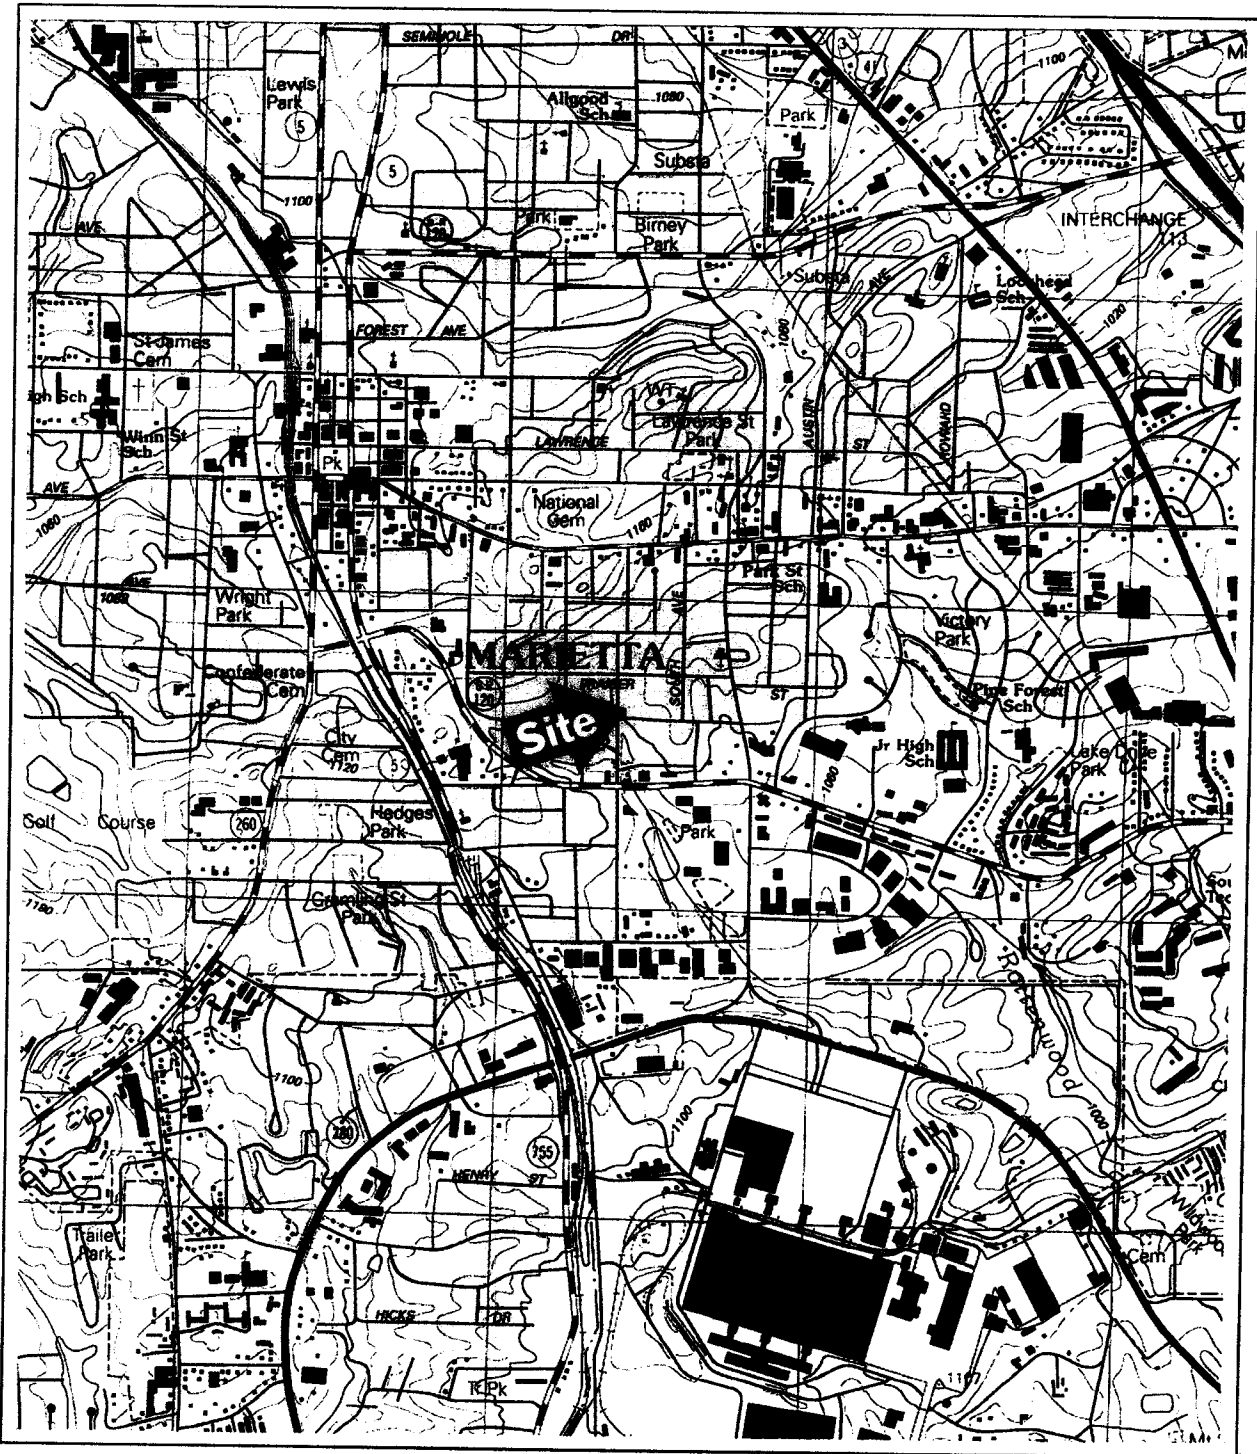
Figure 2: USGS Topographic Quadrangle  
(Marietta, Georgia Quadrangle)

The ground surface elevation at the subject property ranges from approximately 1,100 feet above mean sea level (AMSL) down to approximately 1,080 feet AMSL. The subject property generally slopes to the southeast toward an unnamed tributary of Rottenwood Creek.
